Appendix I4

Biological Opinion & Biological Assessment

Consultation Number: 02ETAU00-2015-F-0031

RE: CSJs 0253-04-138 & 0253-04-146

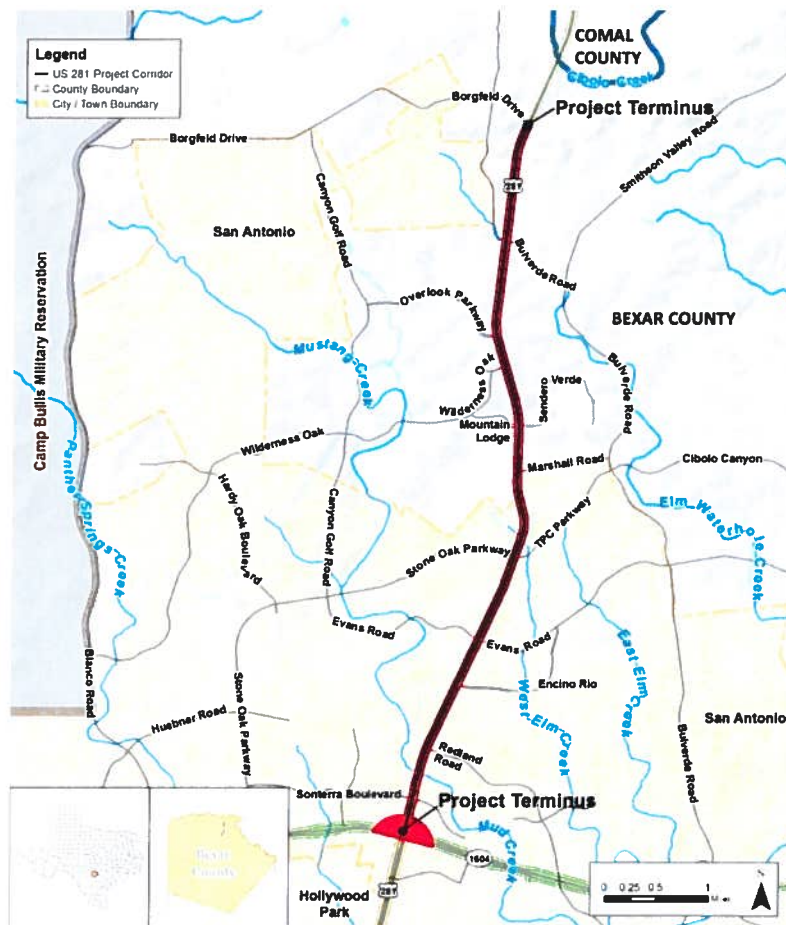
Proposed US 281 improvement project area map.

The US 281 improvements would require fill or excavation in many areas to reach final base elevation for the new construction. Subsurface excavation for bridge supports would include footings and drilled shafts with depths up to 50 feet. Cuts for roadway excavation would range up to 23 feet in depth. Noise walls would be constructed adjacent to some residential areas. The noise wall foundations would require subsurface excavation up to 12 feet in depth. Additional excavation would also be required for project utilities and stormwater drainage with depths ranging from 10 to 15 feet.

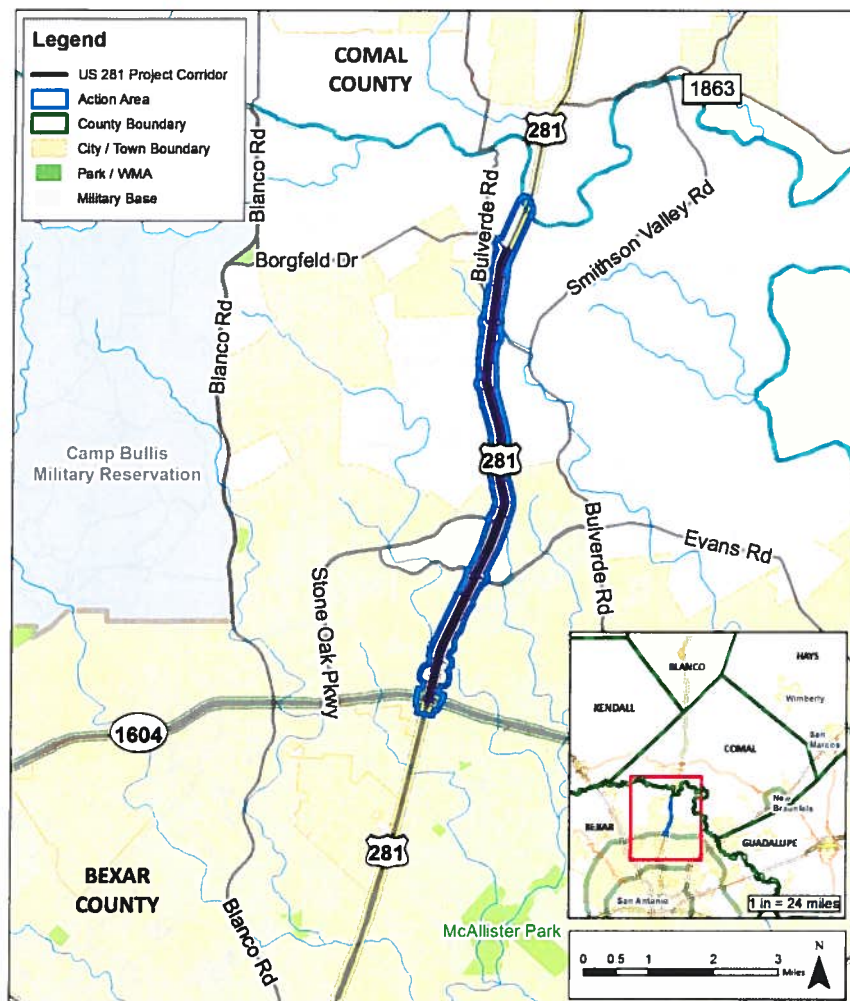
Figure 4. Action area for the US 281 improvement project.

TxDOT has proposed the action area to be 1,530 acres. This includes the project footprint including the proposed new ROW (447 acres), where construction activities would occur, and a buffer of 500 feet extending outward from the project footprint (1,083 acres). The 500 foot buffer was included to capture disturbance from construction activities that have the potential to extend beyond the project footprint. Project-induced changes in surface and subsurface drainage basins, the removal of vegetation, and the addition of impervious cover may impact karst invertebrate habitat within the buffer. The action area was established to include all areas that could reasonably be expected to be directly or indirectly affected by the proposed project. Therefore, the action area proposed by TxDOT, which the Service is using for this consultation, encompasses 1,530 acres, located entirely within the Stone Oak KFR in Bexar County (**Figure 4**).

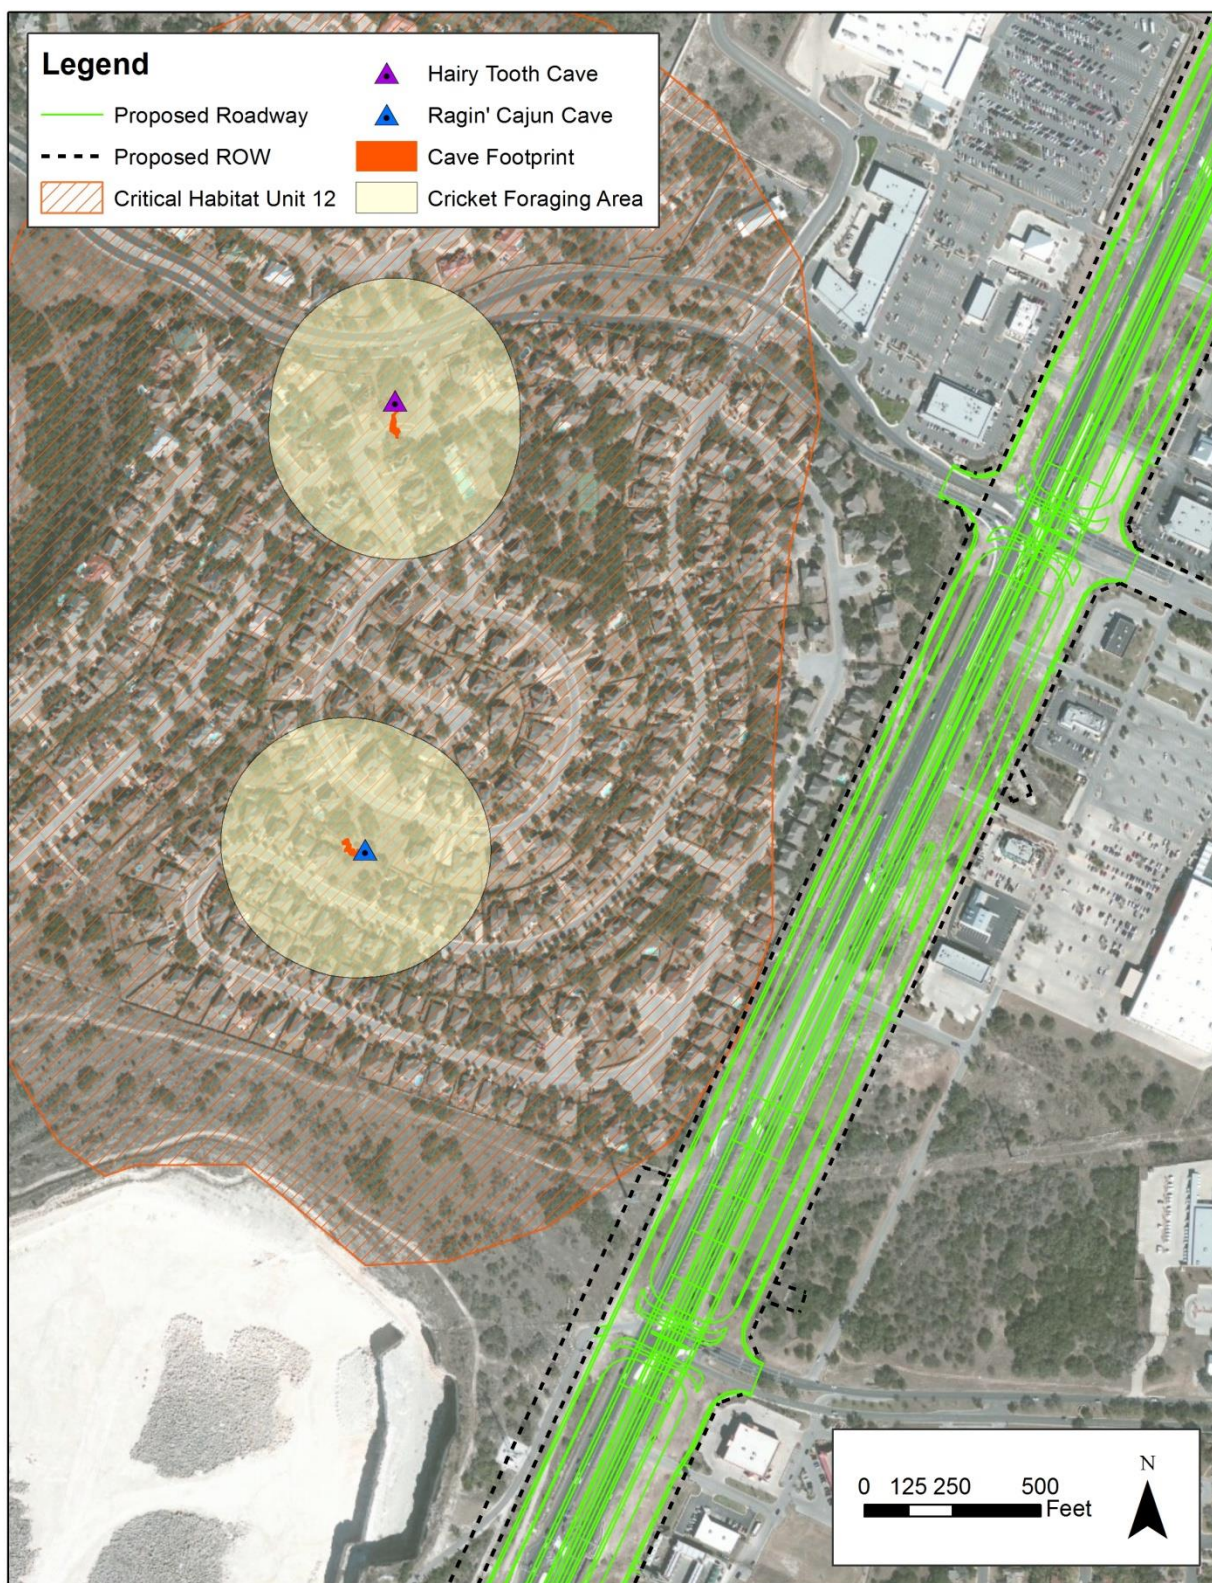
89 **Figure 2-8: Critical Habitat Unit 12**

CHU 12 is a 166 acre unit containing Hairy Tooth and Ragin' Cajun Caves, both known to contain *R. exilis*. This CHU is located on the west side of the US 281 project corridor near Evans Road (**Figure 2-7** and **Figure 2-8**), and is bounded by US 281 to the east, a quarry on the south, and a school and residential development to the west. CHU 12 was delineated by drawing 100-acre circles around the two caves and joining the edges of the two overlapping circles, then subtracting out a quarried-away segment at the south end. CHU 12 is characterized by low-quality habitat due to urbanization within its boundaries and quarrying adjacent to the south of its boundaries. The unit extends into the ROW for a maximum width of 11 feet along 180 feet of the eastern of the CHU, forming a shallow triangle totaling 0.023 acres within the ROW. The 0.023 acres of CHU 12 within the existing US 281 ROW consists of sparse, unmaintained woody vegetation and grasses on limestone bedrock, separated from the remainder of the CHU by a concrete block fence (**Figure 2-9**).

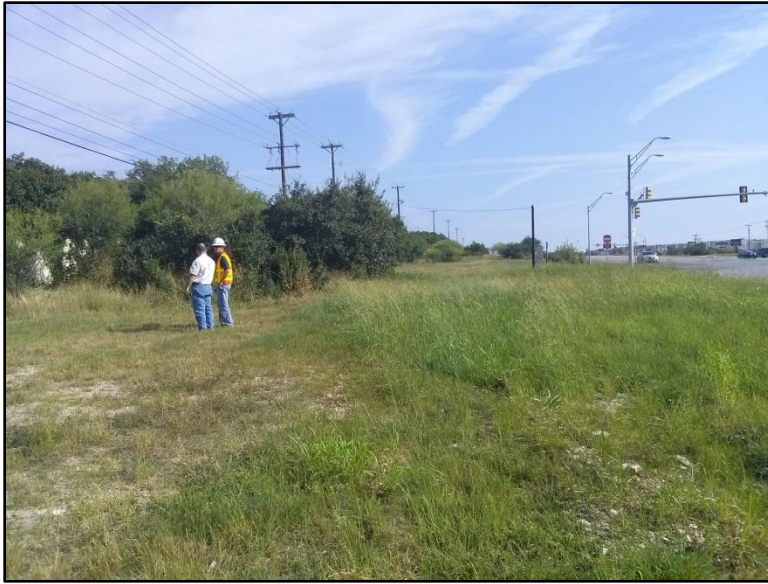
92 **Figure 2-9: Outer edge of Critical Habitat Unit 12 within exiting ROW**

Areas of undisturbed, native vegetation and associated surface wildlife, both of which are considered to be primary constituent elements (PCEs) for karst species habitat, are sparse within CHU 12 and absent within the 0.023 acres within the ROW. Most of CHU 12 consists of single family homes in the Big Spring subdivision on small lots, where little remains of pre-existing natural vegetative and surface hydrologic patterns. In addition to the limitations associated with existing residential and industrial development, CHU 12 exhibits other habitat limitations. Hairy Tooth Cave is surrounded by streets on three sides, and by a residence on the fourth (**Figure 2-10**). It is situated on an undeveloped lot, approximately 0.45 acres in size, about half of which is mowed and half is wooded. Ragin' Cajun Cave is bounded by streets on two sides and by four residences on the other two. It is situated on a fenced lot of 0.6 acres, and consists of natural vegetation. Significant disturbance of the subsurface within and around these caves and CHU 12 due to the installation of water, wastewater, stormwater and other subsurface utilities has already occurred. Impacts to mesocavernous habitat (another PCE) likely occurred during subsurface utility placement; however, the depth of these impacts is unknown. Previous subsurface impacts extend outward from the CHU in the existing ROW where stormwater conveyances were placed across the ROW during the original construction of US 281. The depth of existing subsurface impacts in the ROW is 13 feet below grade.

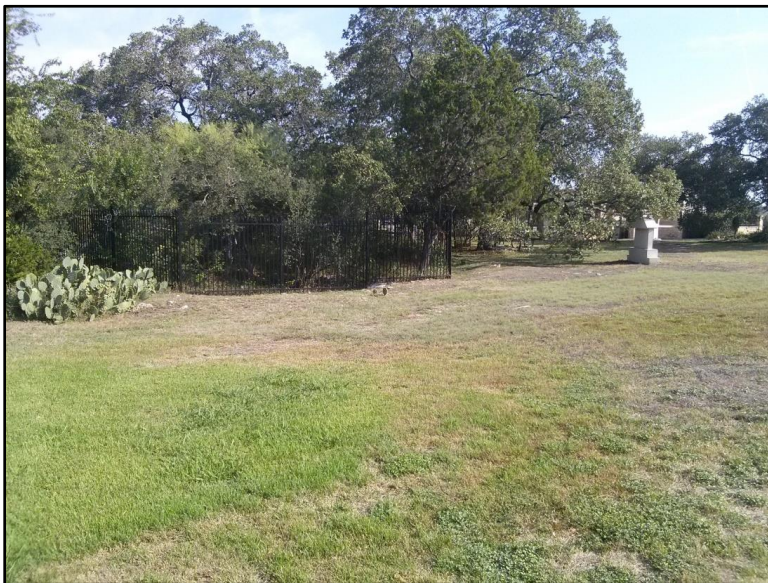
95 **Figure 2-10: Hairy Tooth Cave within Critical Habitat Unit 12**

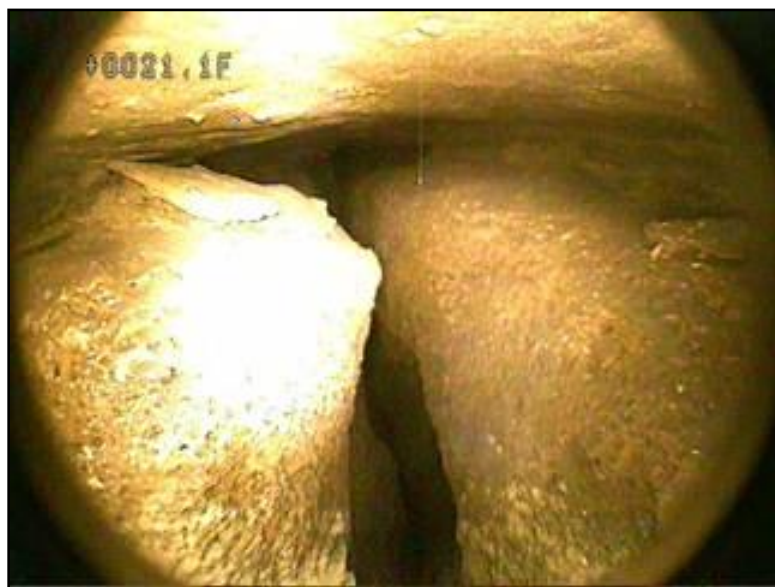
Geotechnical boreholes are typically small diameter (2 to 12 inch) holes that do not result in total destruction of karst voids. The depth of geotechnical boreholes can vary between 30 and 70 feet depending on the needs of the project. When a void is encountered in a borehole, the drill bit will penetrate the ceiling or wall of the void, causing some debris (drilling tailings) and water (if used as a bit lubricant) to enter the void. Voids can be detected during drilling by a bit drop or change in drilling pressure. Voids can be assessed using a downhole camera for the presence of karst invertebrate habitat (**Figure 3-1**). If habitat is present, baiting and trapping of karst invertebrates to determine presence or absence may be possible depending on the size and configuration of the void. As voids encountered in geotechnical boreholes are located at some depth within a borehole, the potential for climate alteration is minimal. Drilling of the borehole may induce airflow to subsurface voids; however, a narrow opening, typical of most boreholes would not result in as much desiccation as would occur if the void were directly exposed to the surface. Boreholes are typically plugged with bentonite clay, or backfilled with the material removed to prevent the introduction of potentially contaminated surface runoff into groundwater. Voids within boreholes may be preserved by plugging the borehole above the void.

Figure 3-1: A subsurface void intersected by a geotechnical borehole as viewed with a downhole camera

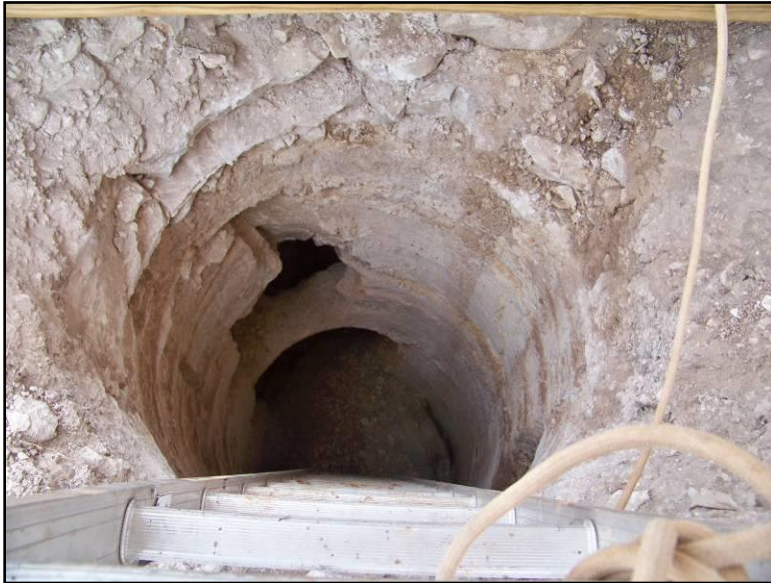
Drilling for the installation of support piers for bridges and ramps involves drilling larger shafts ranging from 3 to 15 feet in diameter with depths typically between 12 and 40 feet. Drilled shafts for piers have the potential to entirely destroy a karst void, or remove a significant portion of it, depending on the diameter of the shaft. A void encountered in a drilled shaft may be exposed to significant climate alteration, though perhaps not as much as in the cases of milling and excavation (Figure 3-2).

Figure 3-2: A three-foot diameter drilled pier shaft intersecting a subsurface void

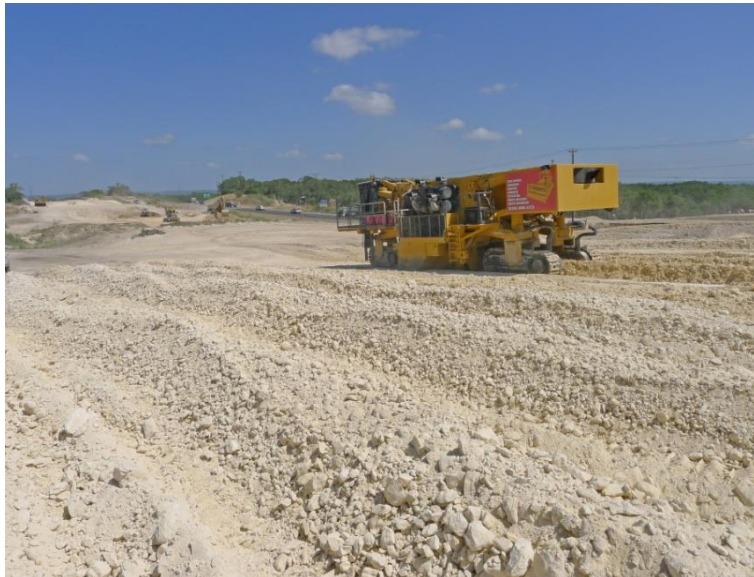
Surface milling is used to evenly lower the grade of bedrock by several inches at a time over wide areas to provide an even surface for subgrade layers in roadway projects. As a milling machine passes over an area it removes surface bedrock and leaves behind a pile of cuttings including small rocks and dust (Figure 3-3). Cuttings are then piled up by other machines and loaded into dump trucks for removal or reuse. The milling machine operator does not have a good view of the milling action and may not know if a void has been encountered. Graders are also used to scrape materials from the ground surface after milling to achieve a particular slope. When the area is scraped free of debris the void should become apparent, unless the void is completely destroyed by milling or grading equipment. Impacts to voids encountered by milling and grading activities will vary depending on the vertical and horizontal extent of the void, and whether the void is situated in the floor of the milled or graded area or in the wall. If a large portion of a void is exposed, climate alteration will be exacerbated. If only a narrow opening to void is created, climate alteration may be minimal. In either case, flooding can still occur on the floor of the downcut area, especially if it has the aspect of a large trench, channeling floodwaters.

Figure 3-3: Tailings from milling machines may conceal voids

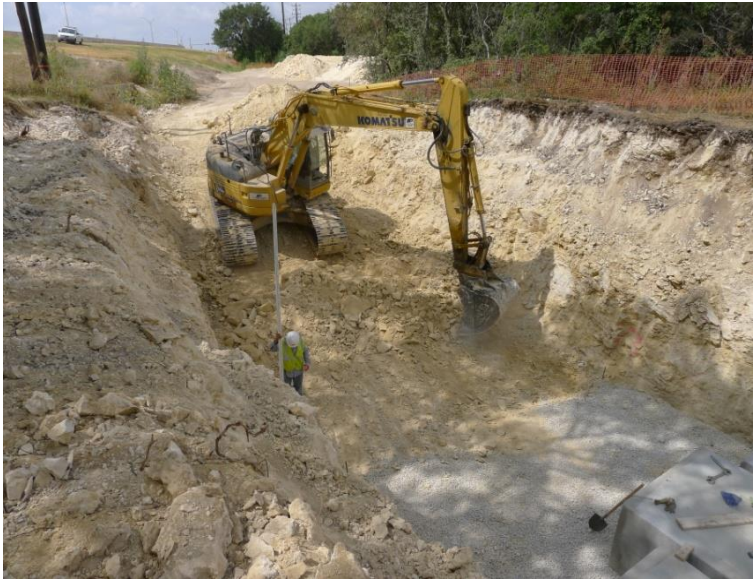
Excavation equipment such as trackhoes and trenchers are typically used in smaller areas than milling and grading equipment; however, the depths impacted may be greater. Most excavation and trench work on roadway projects is for the placement of stormwater conveyances and water quality facilities. Trackhoe operators typically have a good view of the excavation and can visualize voids as they are encountered (**Figure 3-4**). Trenchers come in two basic types, either a large wheel or a chainsaw-like arm, both with large rock-cutting teeth on them. Since the trench is narrow, visibility for detecting voids encounters is minimal. Voids exposed in excavations and trenches would be subject to similar climate alterations as those in pier drill holes, and would be particularly subject to flooding from rainfall runoff.

Figure 3-4: A trackhoe removing bedrock

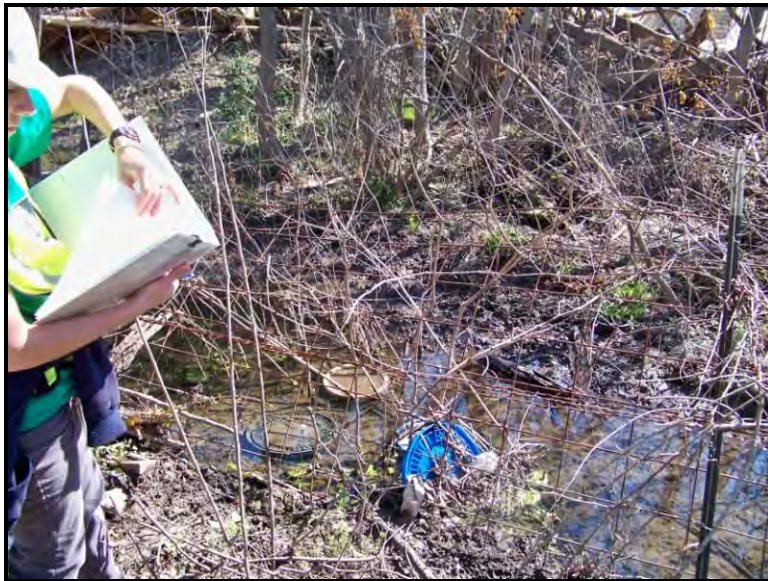
281-002, spring This is a spring that lies just outside of the eastern US 281 right of way, south of Borgfeld Road. Part of the spring pool is within the ROW, but the apparent spring source is on private land where right of entry was not granted (Figure 2). The spring appears to emerge from sediments, with no obvious single source. The spring pool measured 2 by 7 m (6.6 by 23 ft) when first recorded on 26 February 2010. Surface flow from the spring sank into sediments just downstream of the pool. While any spring in this area is potential habitat for *Eurycea* salamanders, the apparent lack of a bedrock portal for salamanders to retreat into makes that unlikely.

Figure 2. View of the spring pool at feature 281-002.

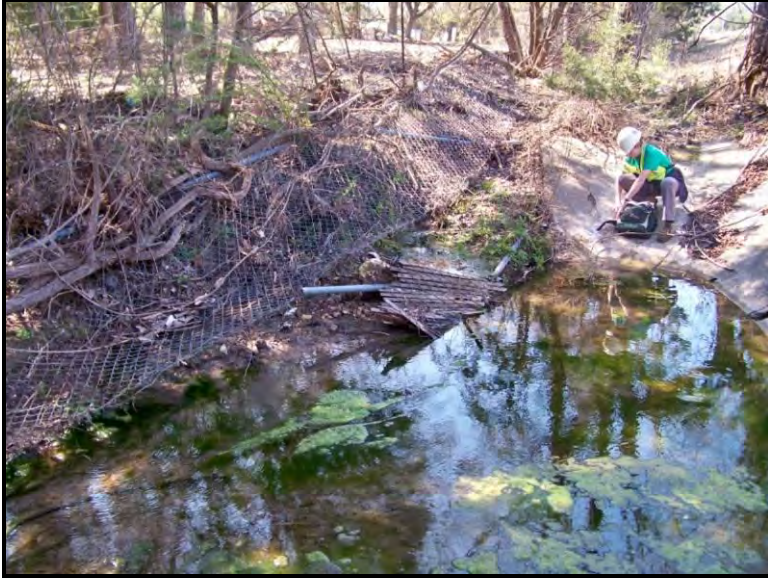
281-003, spring This spring is located along the eastern US 281 ROW just south of Borgfeld Road. There are five distinct spring sources; four of these emerge from sediment in an area that is 7 m (23 ft) long by 2 m (6.6 ft) wide by 0.3 m (1 ft) deep. The fifth emerges from a weep-hole pipe at the base of a concrete skirt constructed as part of the highway (Figure 3). The source of this water is unknown. The spring pool is bisected by the ROW limit. This site was considered to be potential habitat for *Eurycea* salamanders and was sampled on 13 May, 20 May, 2 June, 11 June, 16 June, and 25 June 2010. No salamanders were found during these surveys.

Figure 3. View of the spring pool at feature 281-003.

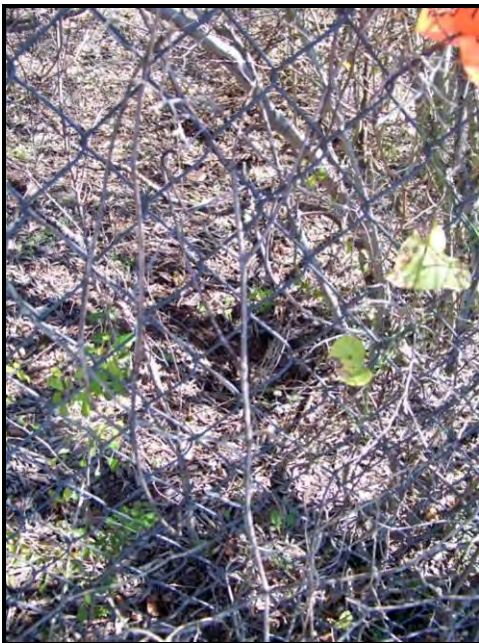
281-004, closed depression This is a closed depression that is situated on private property where right of entry was not granted. It is just across a fence line at the base of a persimmon tree (Figure 4). The feature is 0.7 m (2.3 ft) long, 0.5 m (1.6 ft) wide, and 0.25 m (0.8 ft) deep. It may be a solutional sinkhole, or it could be an animal burrow. It was recommended for excavation, but no right of entry was available.

Figure 4. View of feature 281-004 through fence.

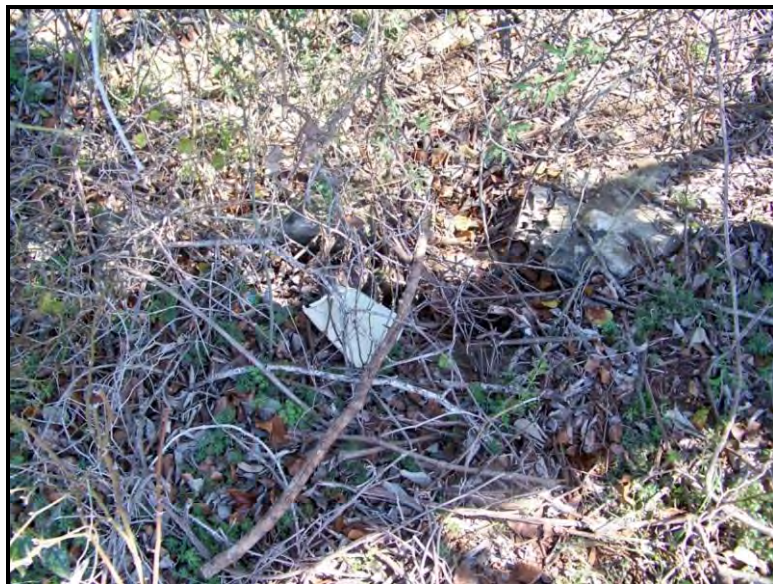
281-005, non-karst closed depression/animal burrow This closed depression is mostly in the ROW, but is crossed by a fence and is partially on private property (Figure 5). A hackberry tree is growing out of one side of it. It is 1.5 m (4.9 ft) long, 0.7 m (2.3 ft) wide, and 0.2 m (0.7 ft) deep. Excavation was conducted on 10 September 2010 for 1.5 person-hours and 0.15 m³ (5.3 ft³) of material was removed. It was determined to be a burrow made by animals exploiting the roots of the hackberry tree rather than a karst feature

Figure 5. Overview of feature 281-005. Chain link fence can be seen crossing the feature.

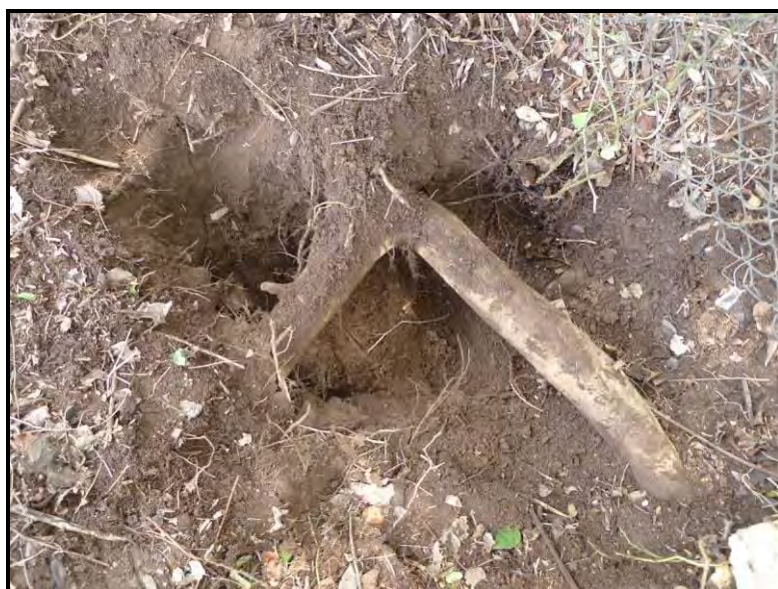
Figure 6. Feature 281-005 after excavation. It is a burrow made by animals exploiting a root system.

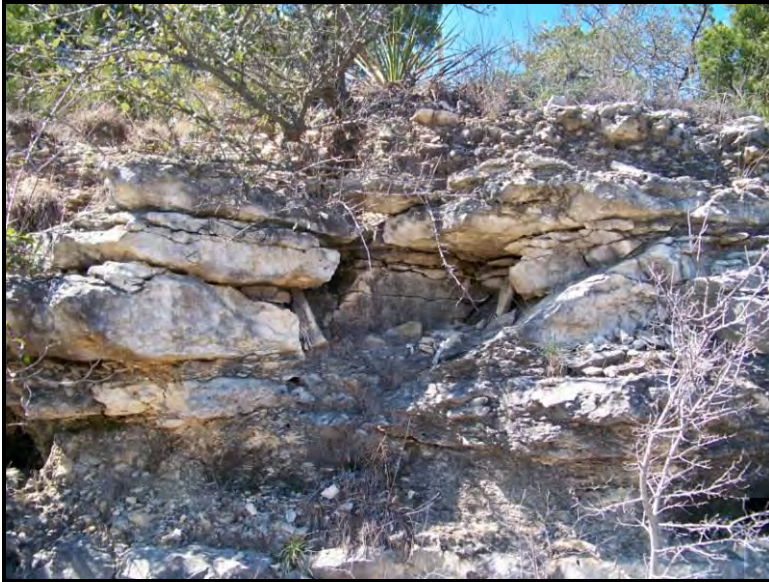
281-006, enlarged fracture This feature is in the road cut on the west side of US 281. The entrance to it is 0.8 m (2.6 ft) wide, 0.4 m (1.3 ft) high, and it extends into the road

Figure 7. Overview of feature 281-006.

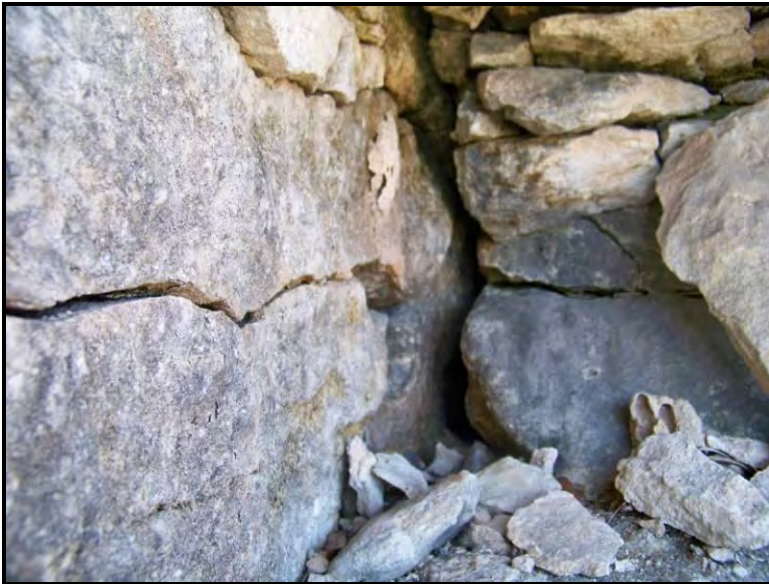
cut for 1 m (3.3 ft) (Figure 7). It is an enlarged fracture with no infill (Figure 8). Harvestmen (*Leiobunum townsendi*) were observed in this feature. This feature was not recommended for excavation (Table 1).

Figure 8. Interior of feature 281-006.

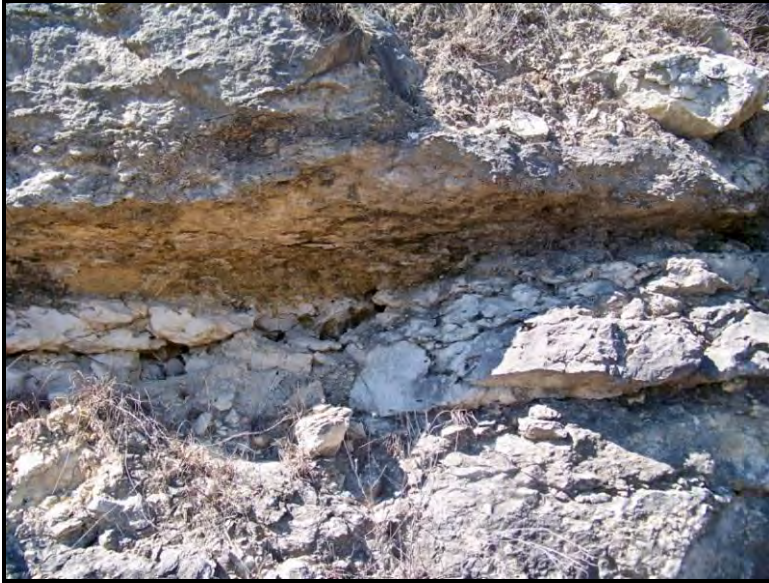
281-007, solution cavity/enlarged bedding plane This feature is situated in the road cut on the west side of US 281. The entrance to the feature is 0.7 m (2.3 ft) wide, 0.5 m (1.6 ft) high, and it extends into the road cut for 0.5 m (1.6 ft) (Figure 9). It is an enlarged bedding plane with no infill (Figure 10). A list of fauna encountered in 281-007 can be found in Table 3. This feature was not recommended for excavation (Table 1).

Figure 9. Overview of feature 281-007.

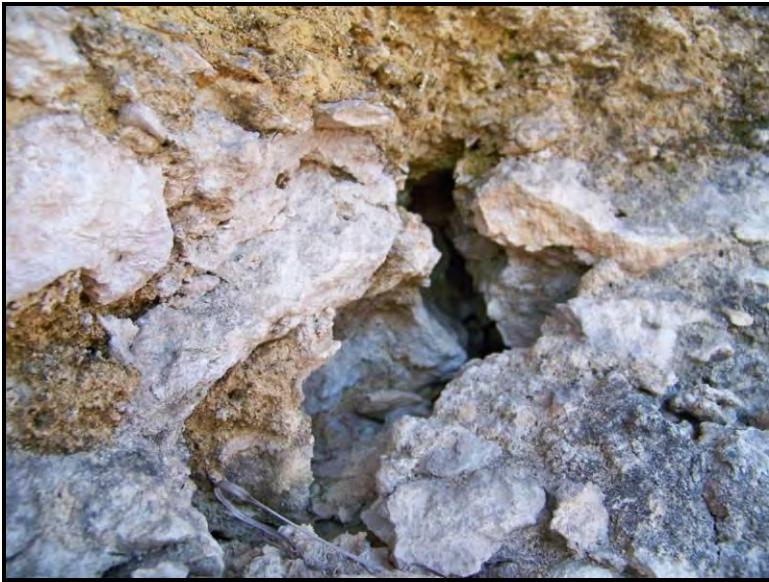
Figure 10. Interior of feature 281-007.

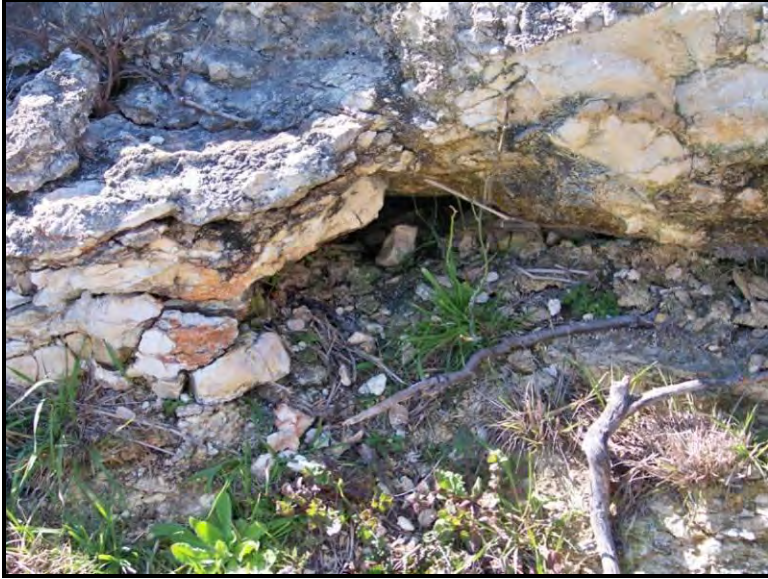
281-008, solution cavity/enlarged bedding plane This is an enlarged bedding plane feature in the road cut on the west side of US 281 (Figure 11). The entrance is 0.4 m (1.3 ft) wide, 0.1 m (0.3 ft) high, and it extends into the road cut for at least 1.5 m (4.9 ft) (Figure 12). It is developed in pulverulitic limestone and has no sediment infill. This feature was not recommended for excavation (Table 1).

Figure 11. Overview of feature 281-008.

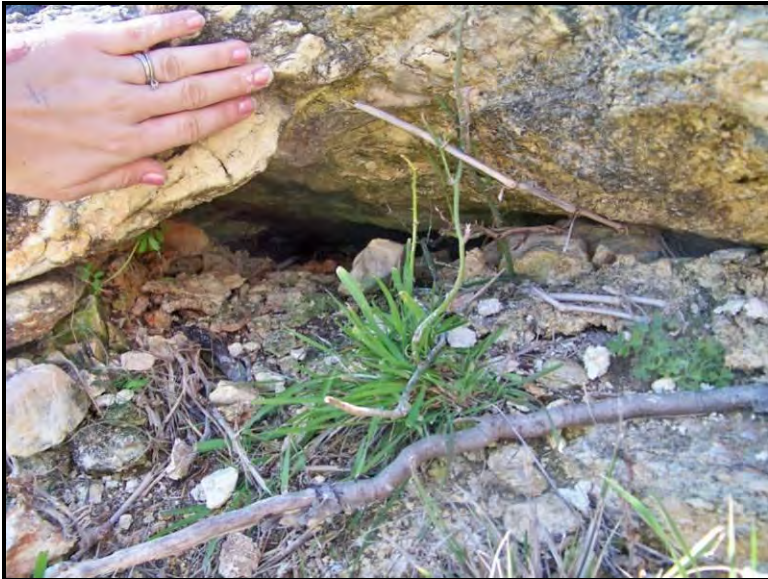
Figure 12. Interior of feature 281-008.

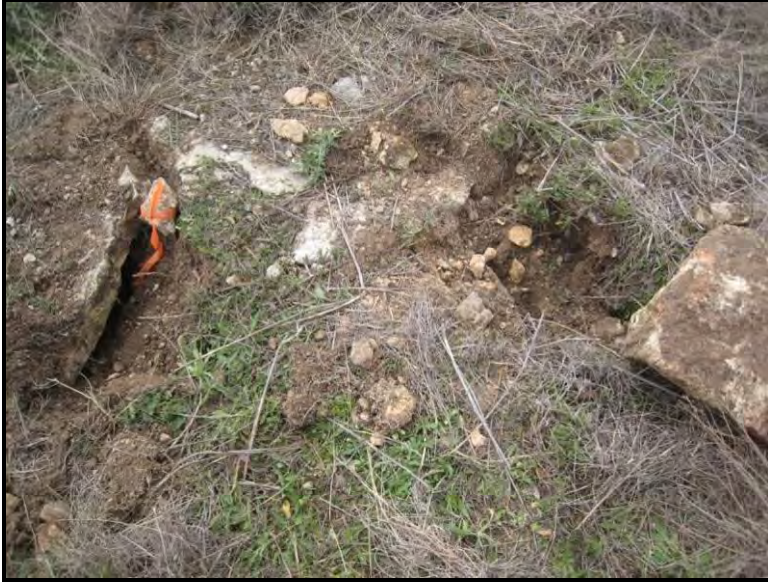
281-009, closed depressions This is a pair of closed depressions on private property on the west side of US 281 (Figure 13). The feature measures 1.5 by 1 m (4.9 ft by 3.8 ft), and is 0.3 m (1 ft) deep (Figure 14). It may be karstic in origin, or it may have an anthropogenic origin related to a nearby natural gas pipeline. Excavation would be needed to make that determination, and was recommended. ROE for excavation purposes was not granted.

Figure 13. Overview of feature 281-009.

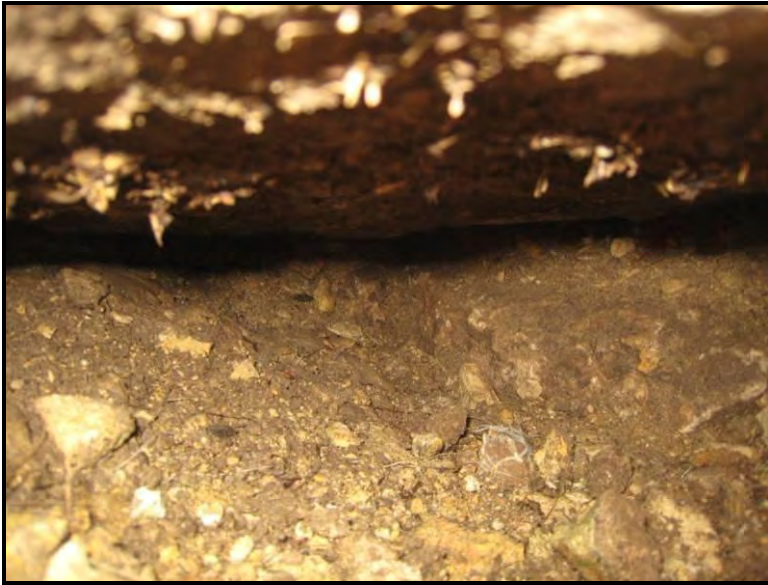
Figure 14. Interior of feature 281-009.

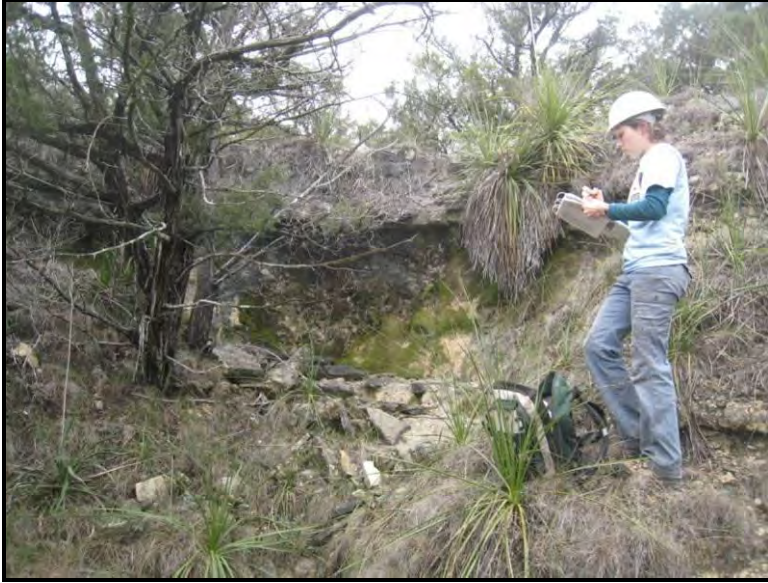
281-010, spring This is a seep spring located on private property on the west side of US 281 (Figure 15). It flows from the travertine-covered base of a 3 m (9.8 ft) tall cliff in an area that is 2 m (6.6 ft) long by 1 m (3.3 ft) wide, but it does not have an identifiable portal (Figure 16). A small amount of water was flowing from it when assessed on 1 March 2010. It is possible habitat for *Eurycea* salamanders, but not likely due to the apparent lack of a portal. It was not sampled for salamanders due to revocation of ROE.

Figure 15. Overview of feature 281-010.

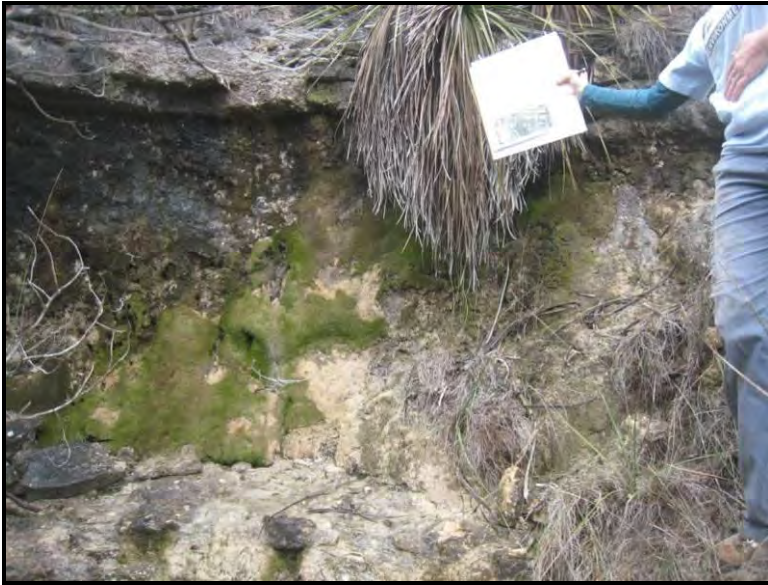
Figure 16. Feature 281-010 exhibits travertine deposition.

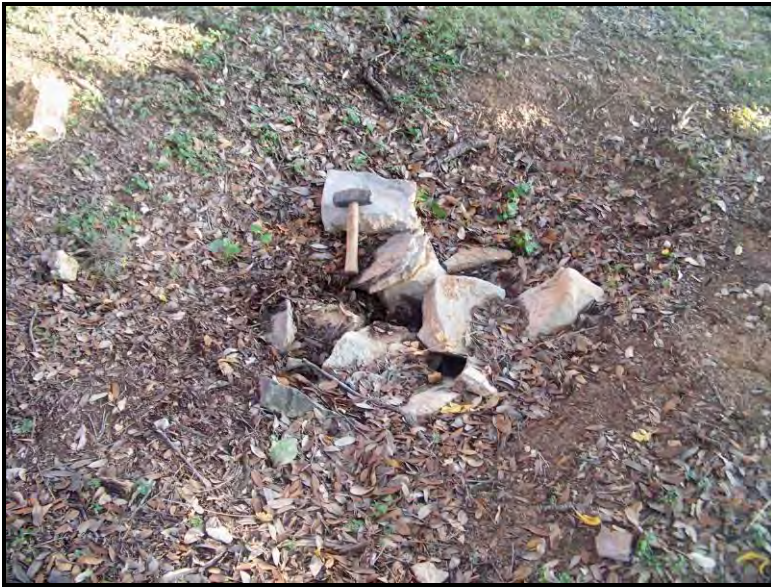
281-011, non-karst closed depression This depression is located on private property between a house and some storage units. When first located it was 1.5 m in diameter and 0.7 m deep, and filled with loose rocks (Figure 17) and snakes. Excavation was recommended to determine its origin. This was conducted on 10 August 2010. During this excavation effort, 9.25 person-hours of effort were expended and 1.25 m³ (44 ft³) of material was removed. This resulted in a rectangular depression 2.5 m (8.2 ft) long, 1.5 m (4.9 ft) wide, and 1 m (3.3 ft) deep, with a floor of hard-packed soil (Figure 18). Trash was removed from this excavation, and a rusty metal pipe leads into it (Figure 19). This feature appears to be some kind of old septic facility, and is not karst-related. A list of fauna encountered in 281-011 can be found in Table 4.

Figure 17. View of feature 281-011 prior to excavation.

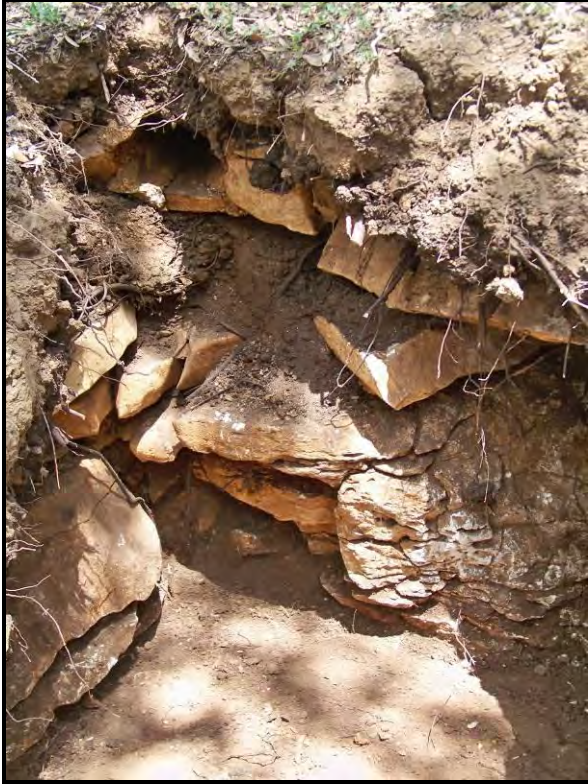
Figure 18. View of feature 281-011 after excavation.

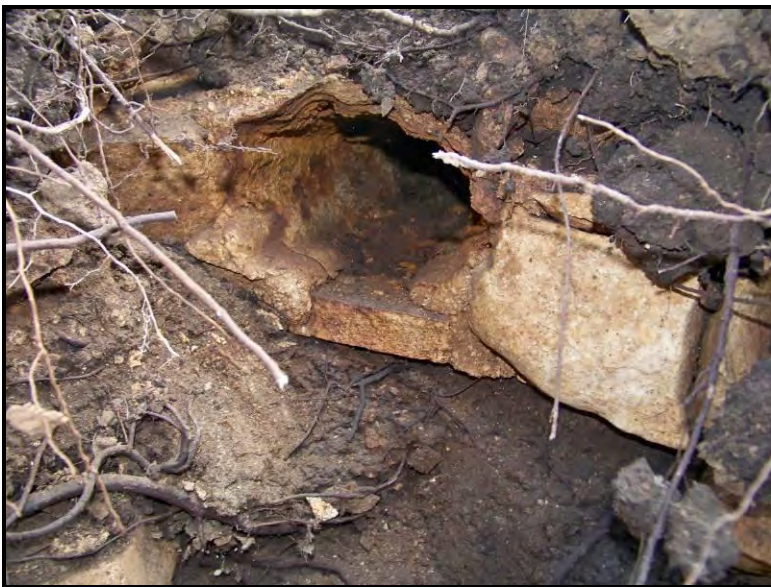
Figure 19. Corroded metal pipe leading into feature 281-011.

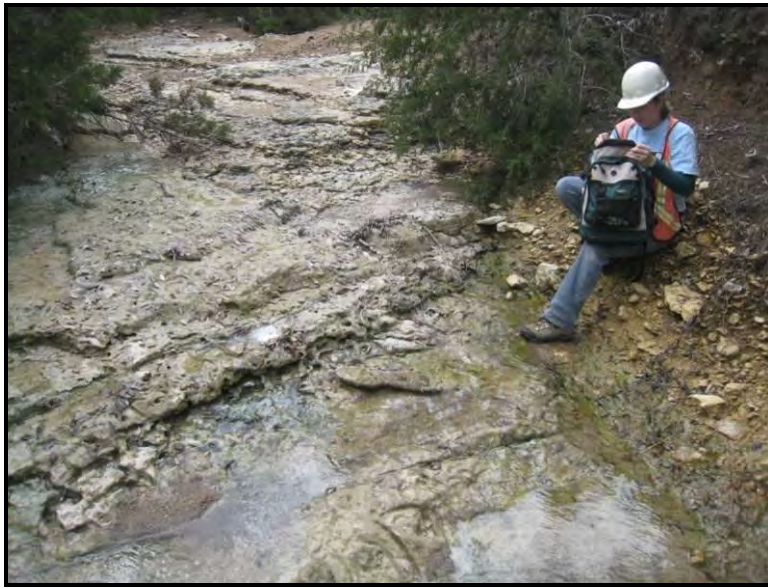
281-012, spring This is a spring that emerges from two small bedrock openings in the middle of a creek bed that are 0.2 m (0.7 ft) in diameter. When the site was recorded on 1 March 2010, water was flowing from both the spring orifices and from upstream in the creek (Figure 20). It is not known if the water coming from the spring is merely pirated from the stream flow nearby, or if it has a more distant source. The spring has a well-defined bedrock orifice (Figure 21), which is possible habitat for threatened *Eurycea* salamanders; however it was not sampled due to revocation of ROE.

Figure 20. Overview of spring 281-012. Two spring outlets are present along the bedding plane that cuts diagonally across the picture.

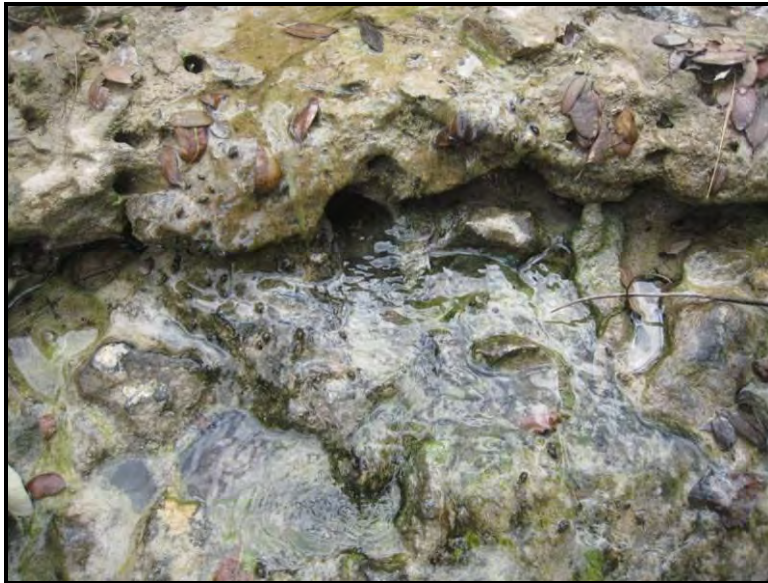
Figure 21. One of two spring outlets at feature 281-012.

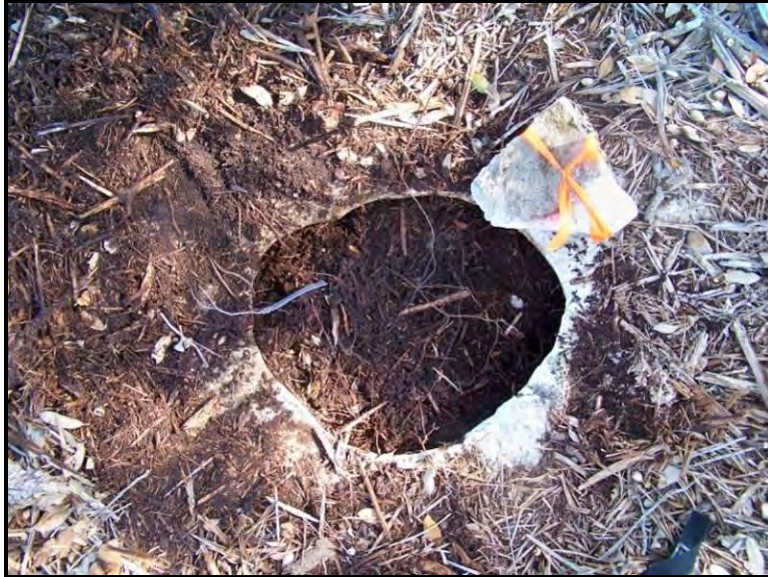
281-013, solutional sinkhole This is a karst feature that was initially 0.4 m (1.3 ft) long and 0.3 m (1 ft) wide. It was developed in bedrock, and the bedrock belled out in shape toward the floor 0.15 m (0.5 ft) below the surface (Figure 22). It was filled with fine soils and leaf litter. Excavation was conducted on 11 August 2010 utilizing 9.75 person hours of effort. The feature was enlarged using a jackhammer to a post-excavation size of 0.75 m (2.5 ft) by 1 m (3.3 ft) with a depth of 0.75 m (2.5 ft), where a floor of bedrock and hard-packed clay was encountered (Figure 23). No mesocavernous voids extended from the feature. A list of fauna encountered in 281-013 can be found in Table 5.

Figure 22. Overview of feature 281-013.

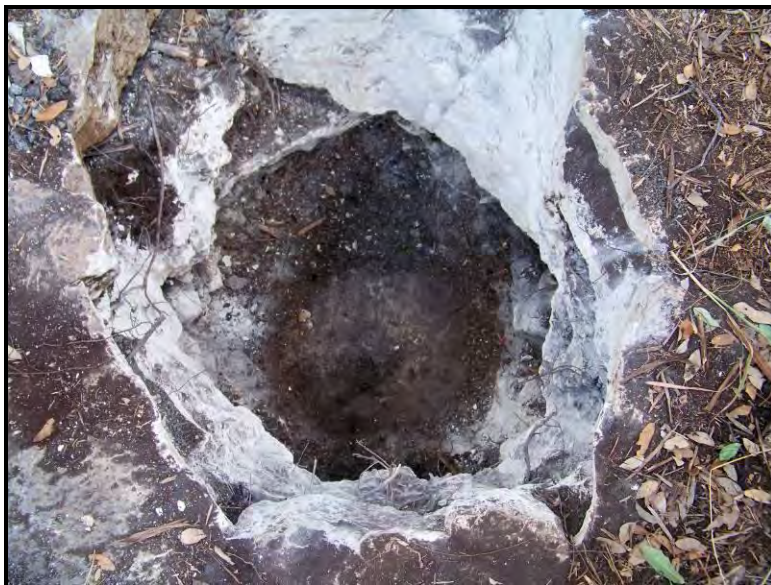
Figure 23. Feature 281-013 after excavation, showing solid floor.

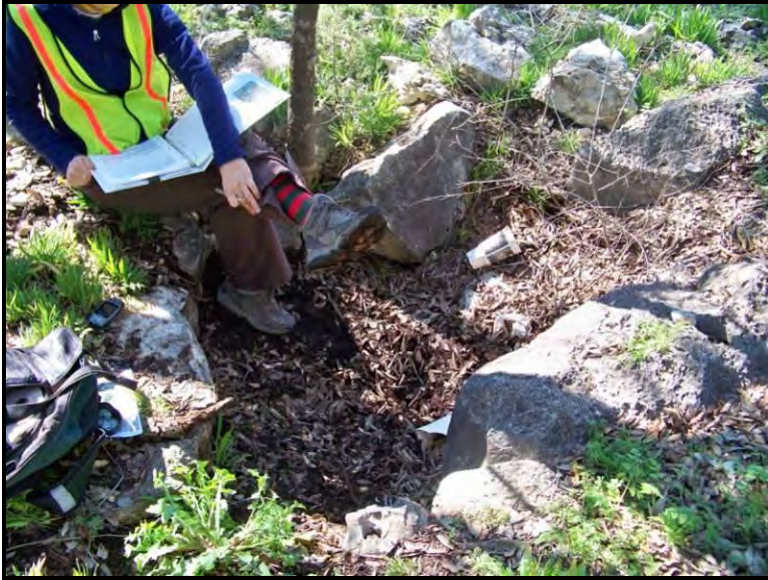
281-014, closed depression This is a depression that when initially assessed was 1.5 m (4.9 ft) long, 1 m (3.3 ft) wide, and 0.6 m (2 ft) deep. It was filled with leaf litter and modern soils (Figure 24). The troglophile meshweaver spider *Cicurina varians* was found in this feature. This feature was excavated on 10 August 2010 utilizing 0.8 person-hours of effort, resulting in the removal of 0.1 m³ (3.5 ft³) of material. A bedrock floor was reached

Figure 24. Overview of feature 281-014 prior to excavation.

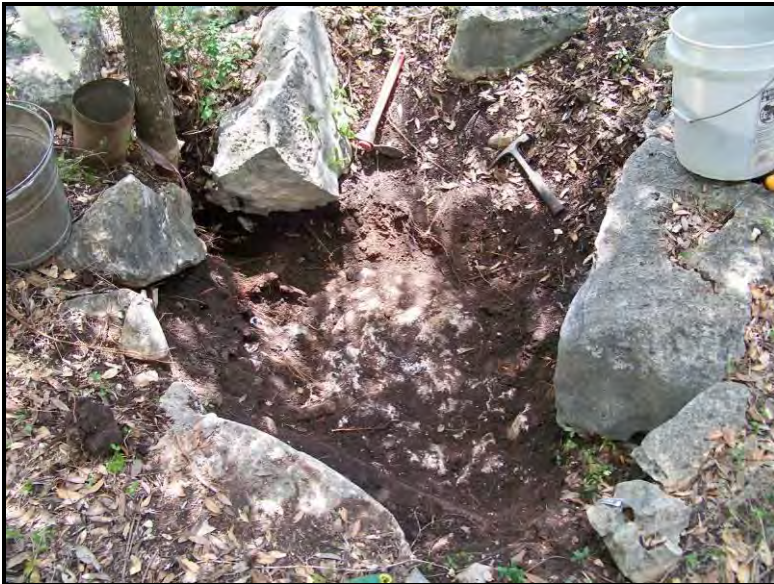
at 0.7 m (2.3 ft) depth (Figure 25), with no mesocavernous voids leading off of the feature. The post-excitation dimensions of the feature were 1.5 m (4.9 ft) long, 1 m (3.3 ft) wide, and 0.7 m (2.3 ft) deep.

Figure 25. Feature 281-014 after excavation, showing bedrock floor.

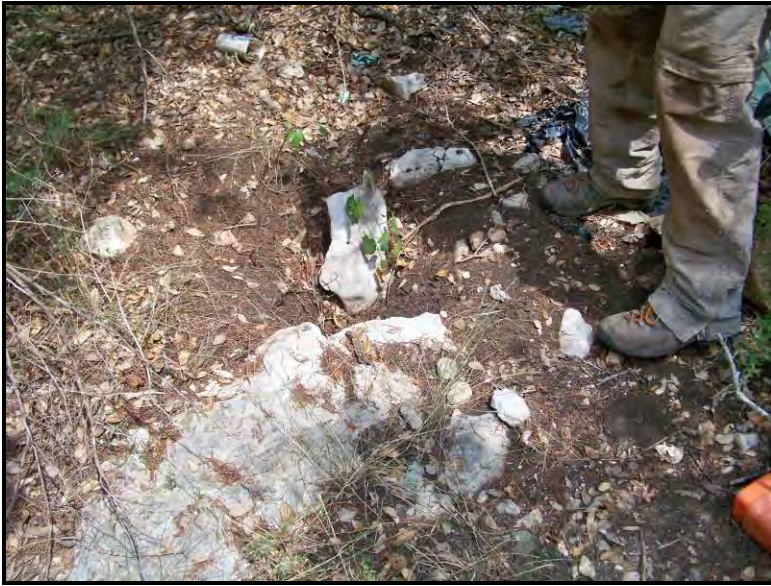
281-015, collapse sinkhole This depression is located on private property. It is 1.5 m (4.9 ft) long and 0.7 m (2.3 ft) wide, and was covered with trash when initially located on 2 March 2010 (Figure 26). It had soil and leaf litter infill that was loose to a depth of 0.2 m (0.7 ft). The troglophilic meshweaver *Cicurina varians* was found in this feature. Excavation was conducted on 10 August 2010 for one person-hour, resulting in the removal of 0.1 m³ (3.5 ft³) of material. A floor of hard-packed clay was reached at 0.25 m (0.8 ft) depth (Figure 27), with no mesocavernous voids extending from the feature. Post-excitation dimensions of the feature were 1.6 m (5.2 ft) long by 0.8 m (2.6 ft) wide by 0.25 m (0.8 ft) deep.

Figure 26. Overview of feature 281-015 prior to excavation.
